PHASE I REPORT
NATIONAL DAM INSPECTION PROGRAM

NAME OF DAM: Indian Lake Dam
STATE LOCATED: Pennsylvania
STREAM: Calendar Run, secondary tributary of Stoney Creek, a tributary
of the Conemaugh River
DATE OF INSPECTION: (May 17 and 30, 1978),

National Dam Inspection Program, Indian
Lake Dam (NDI ID Number 228), Ohio
River Basin, Calendars Run, Somerset
County, Pennsylvania. Phase I Inspection
Report.

PHASE I
NATIONAL DAM INSPECTION PROGRAM
INDIAN LAKE DAM
NDI I.D. NO. 228
DER I.D. NO. 56-103

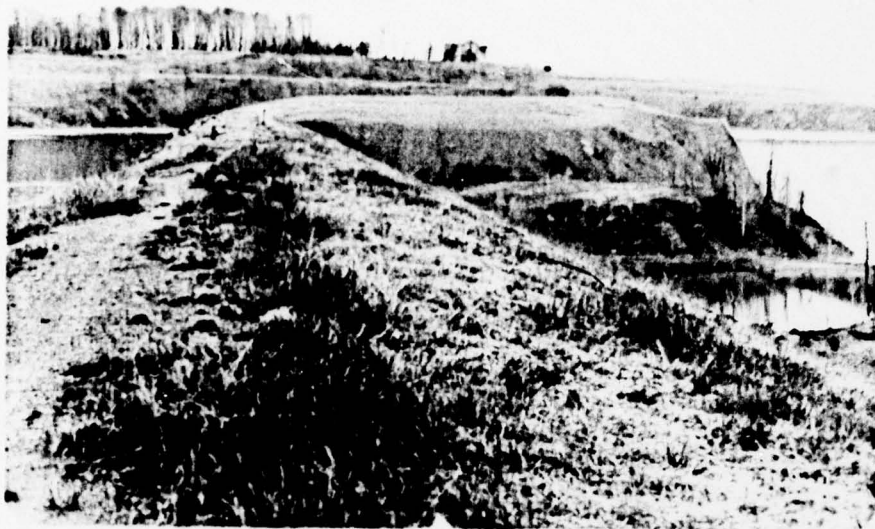
Photograph No. 1

Dam crest.

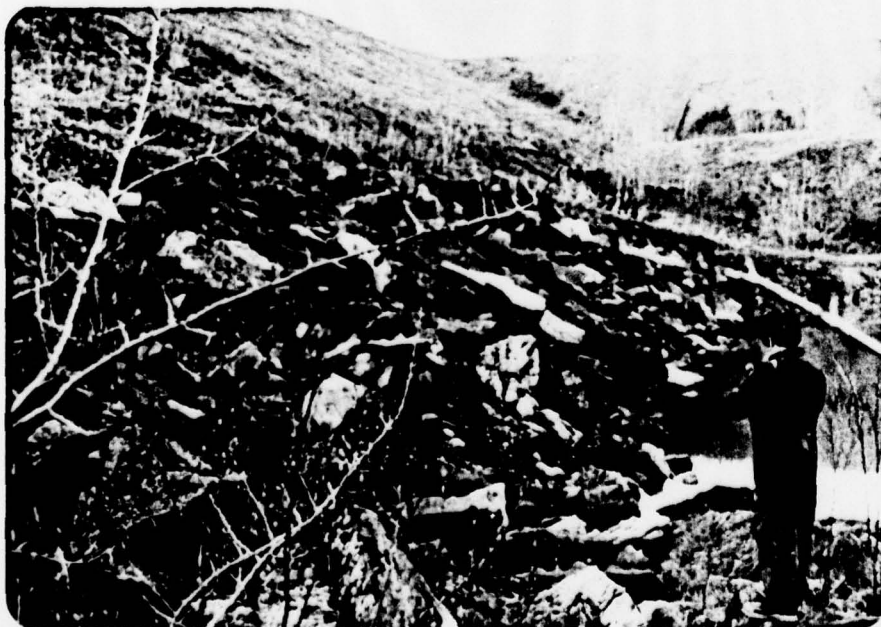
Photograph No. 2

Dam toe.

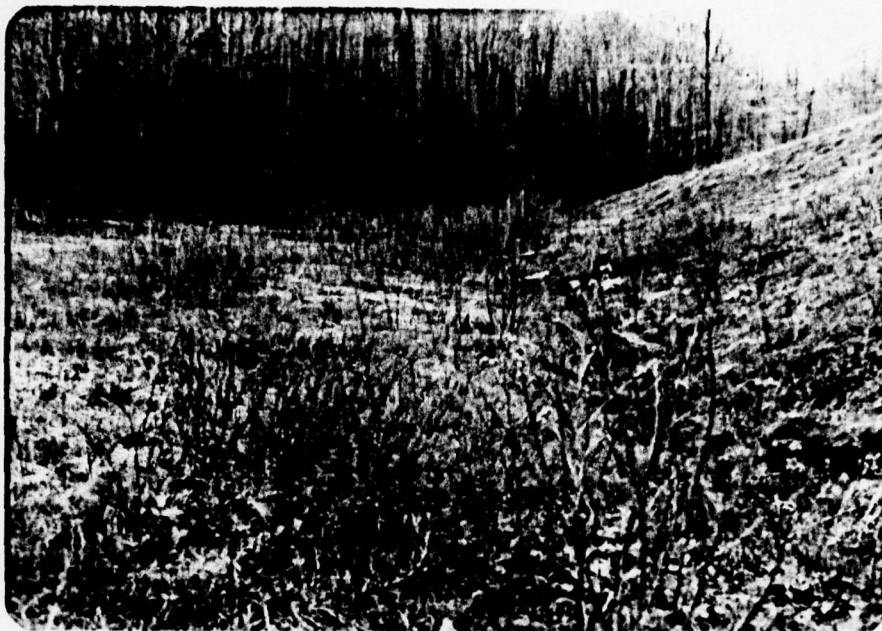
Photograph No. 3
Right abutment.

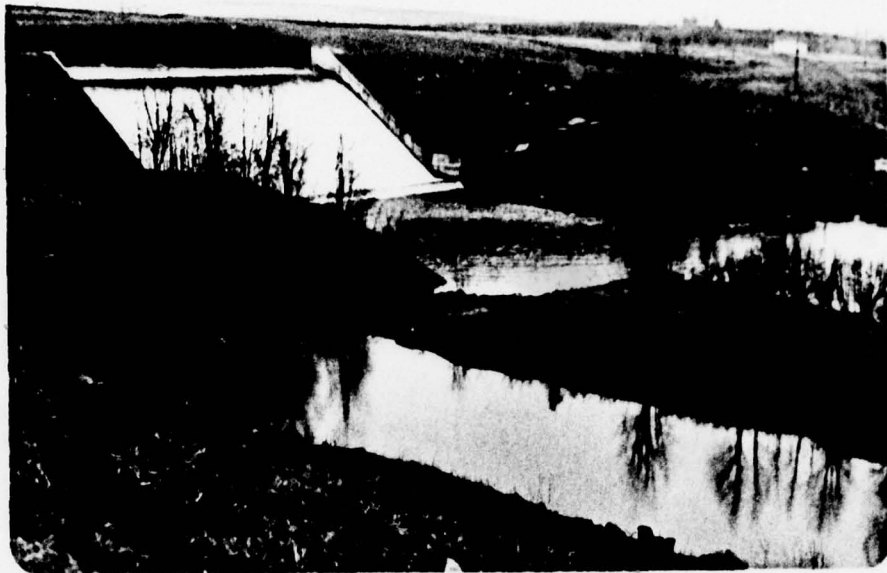
Photograph No. 5
Spillway and plunge pool.

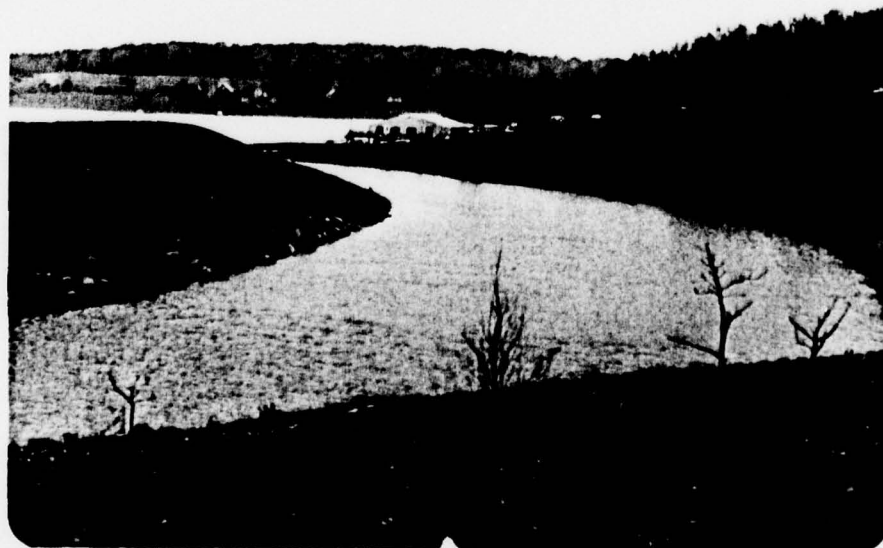
Photograph No. 6
Spillway approach channel.

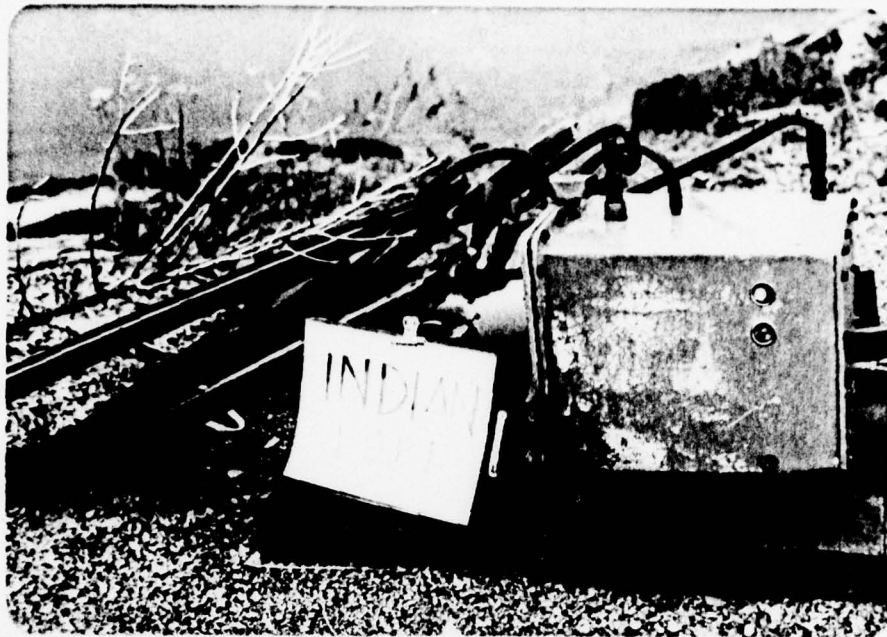
The outlet pipe gate, which is the only emergency drawdown facility for the impoundment, is inoperative and should be repaired immediately.

Photograph No. 7
Outlet pipe valve hydraulic control (nonfunctional).

c. Urgency. Further investigation of the dam and repairs to the outlet pipe sluice gate should be implemented immediately. The other recommendations should be considered as soon as practicable or on a continuing basis.

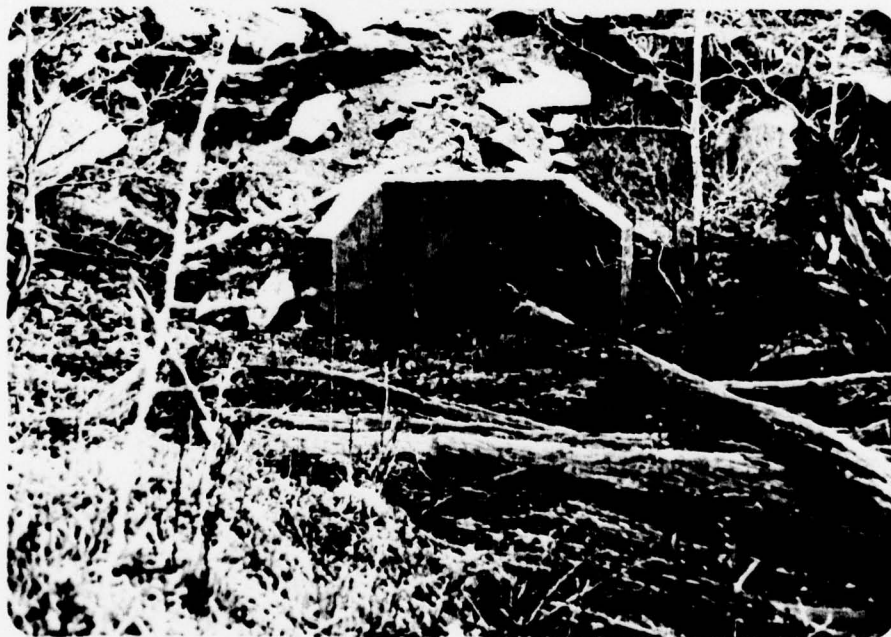
Photograph No. 8
Outlet pipe.

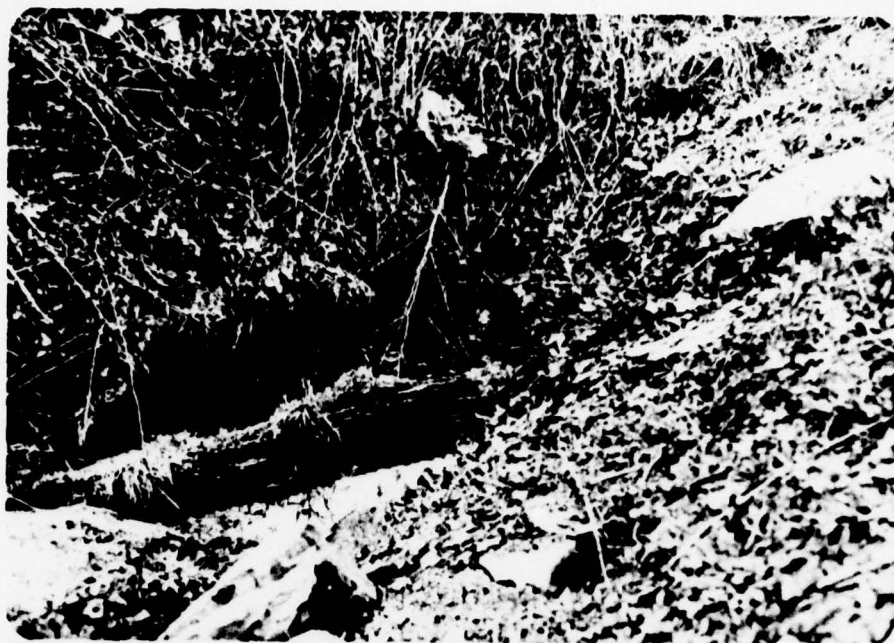
Photograph No. 9
Right abutment toe drain.

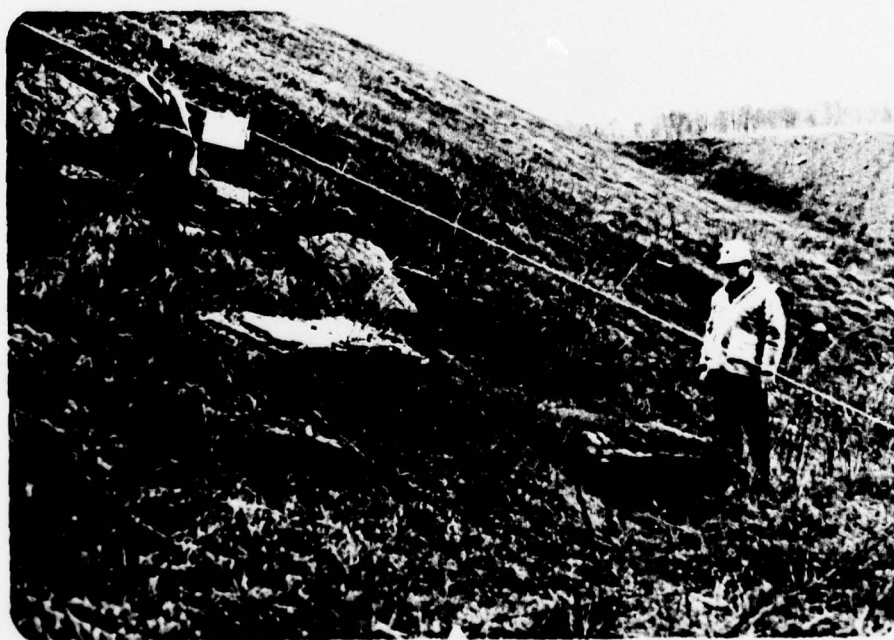
The most significant condition at the dam appears to be the wet areas noted on the downstream face and associated surface irregularities. These conditions suggest possible high phreatic surface (probably perched) through the embankment and consequent instability.

Photograph No. 10
Dam downstream slope irregularity near center.

1. The stability of the dam and methods for controlling existing seepages should be further evaluated in view of the following conditions: (a) the presence of slope irregularities and wet areas on the downstream slope, and (b) numerous seeps on each abutment.
2. Outlet pipe sluice gate controls should be repaired immediately.
3. The crest of the dam should be regraded and the upstream riprap should be extended to the design crest level.
4. The dam and appurtenant structures should be inspected regularly and any unusual conditions should be reported to the appropriate authorities.
5. The owner should develop a formal warning system to alert the downstream residents in the event of emergencies.

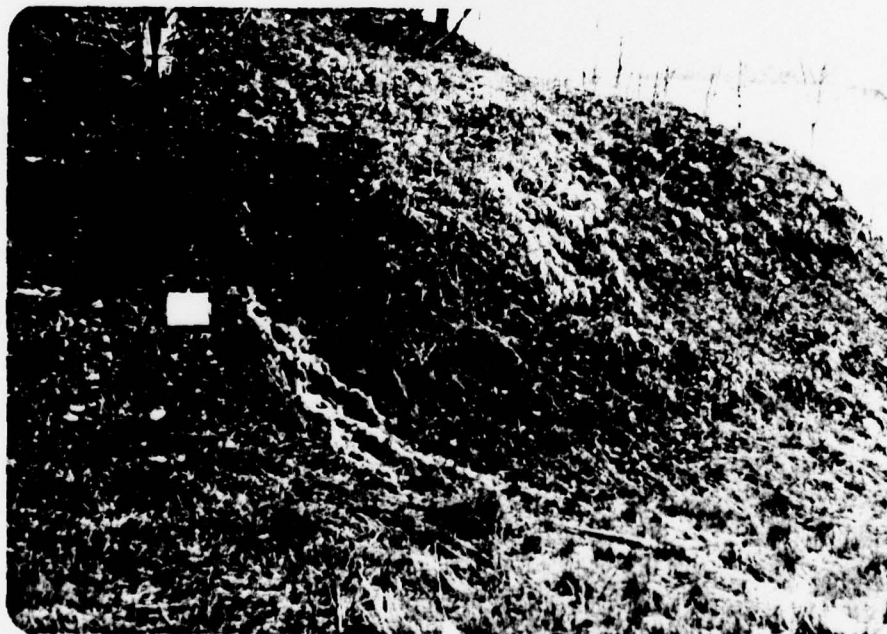
Photograph No. 12

Field observations show that wet areas and slope irregularities exist on the downstream face of the dam, which suggests potential instability of the embankment. Various seepages on the left abutment also require further evaluation, to determine the effect of these conditions on the overall performance of the dam.

Seepage at left abutment.

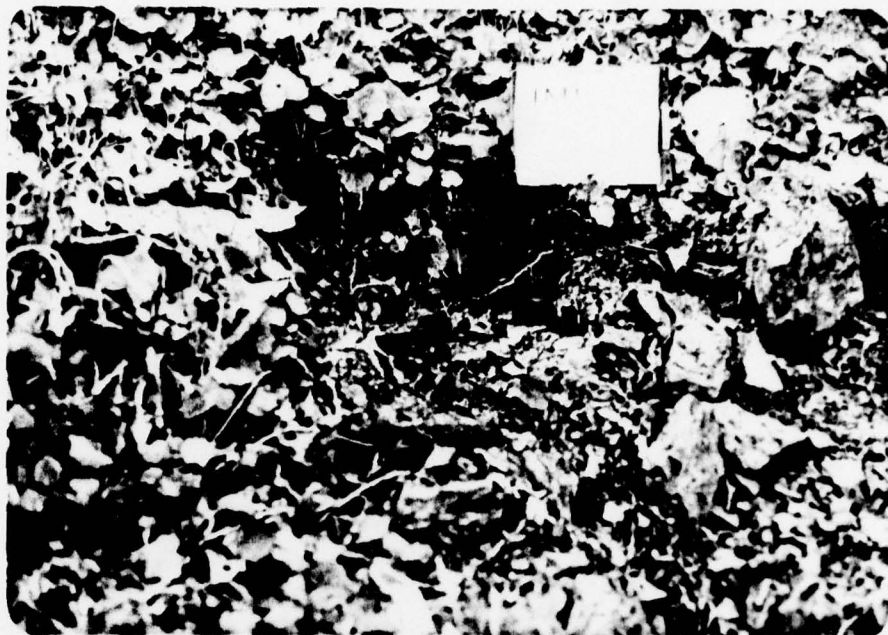
Photograph No. 13
Seepage near spillway right wing wall.

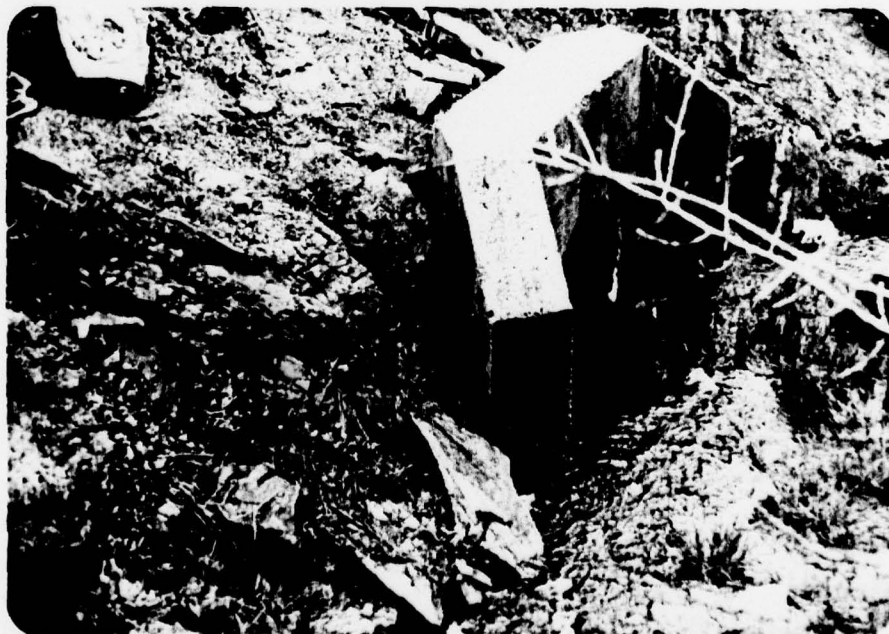
Photograph No. 14
Seepage around outlet pipe headwall.
